# MIFACE Investigation Report #10MI069

## SUBJECT: Hispanic Farm Laborer Electrocuted in Potato Field

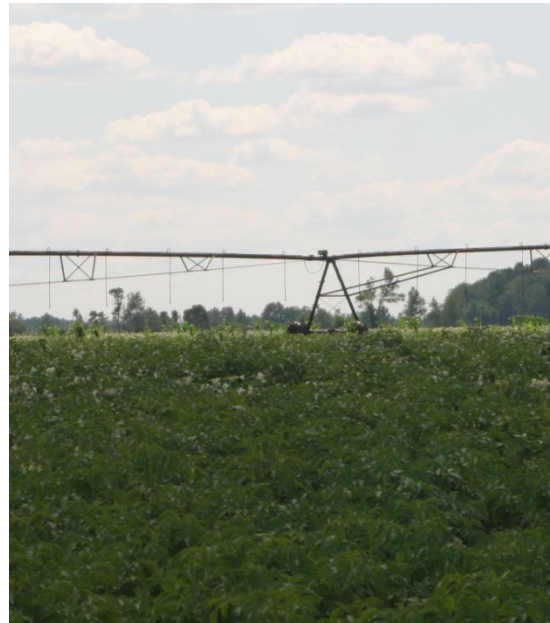
In the summer of 2010, a Hispanic male farm laborer in his 20s was electrocuted in a potato field when he touched the energized cross-brace of an operational self-propelled irrigation system while pulling free growing corn. He was standing in pooled water. One of his two coworkers heard the decedent yell. The coworker looked back and saw the decedent leaning with his left arm on the tower cross brace between the tires. The decedent then fell to the ground. The coworkers called their supervisor at the farm. The farm office called for emergency response and turned the irrigation system off. The decedent was declared dead at the scene. After the incident, the irrigation unit and wiring were examined by multiple firms. The system could not be restarted for inspection. The investigation found that the irrigation system was properly grounded and that underground wires supplying power were “burned off” in four places, thought to be consistent with a lightning strike. A definitive determination could not be made as to how the electrocution occurred.

Figure 1. Irrigation unit involved in incident.

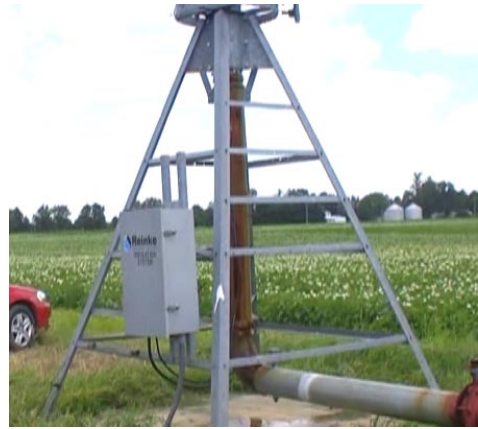
Figure 2. Center pivot involved in incident.

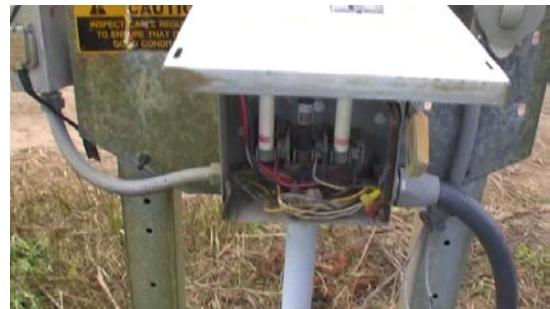
Figure 3. Power supply to Valley Pivot. Valley Pivot plugged into receptacle.

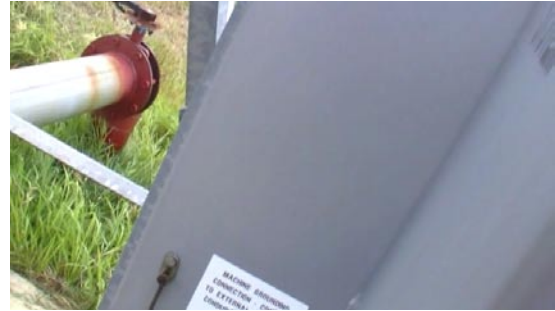
Figure 4. Machine ground of Reinke central pivot.

We started inspecting the actual Reinke unit. We located the ground rod and grounding wire at the main control panel on the unit. It was connected to the ground rod and all equipment grounding wires in the control panel were bonded in the same location to the grounding conductor by mechanical means. The wires entering the panel go through a disconnect switch located about 20 feet away. We traced the cables that leave the control panel up to the top of the unit. There is a smaller control box located on each tower which feeds the motor on each individual tower. These cables pass through each control box onto the next one. The incident happened at the 7<sup>th</sup> tower. We opened up the box and motor on that tower and inspected all of the wiring thoroughly. It was confirmed that all of the grounding wires were in fact connected. We did not find any problems with this system.

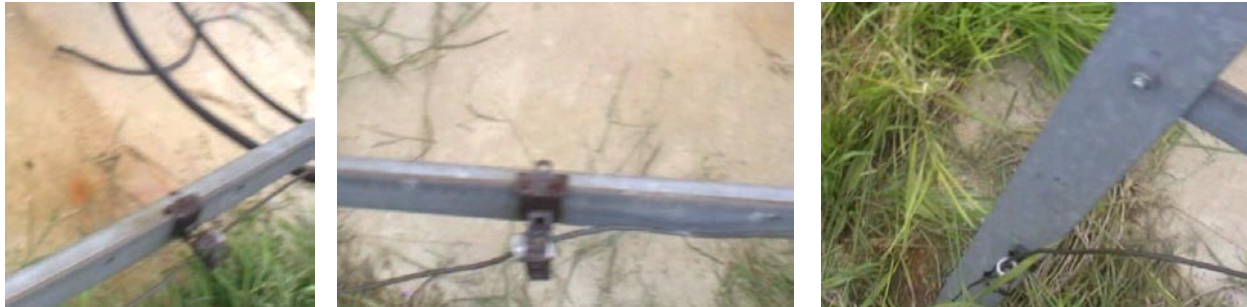
Figures 5-7. Path of Reinke ground wire.

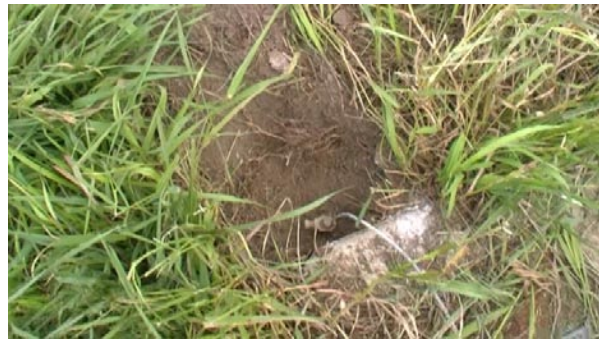
Figure 8. Machine ground of Reinke unit to ground stake.

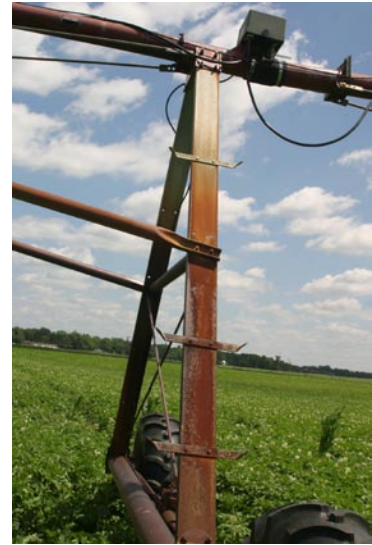
Figure 9. Incident irrigation tower.

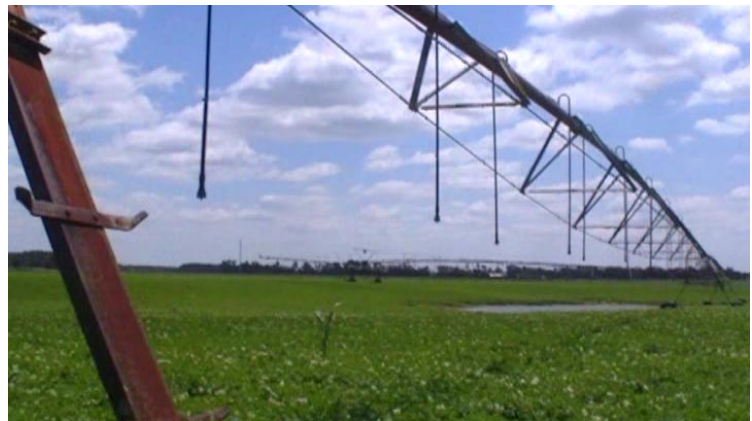
Figure 10. View of Valley and Reinke irrigation units. Reinke Center pivot would be located to the left of the tower.

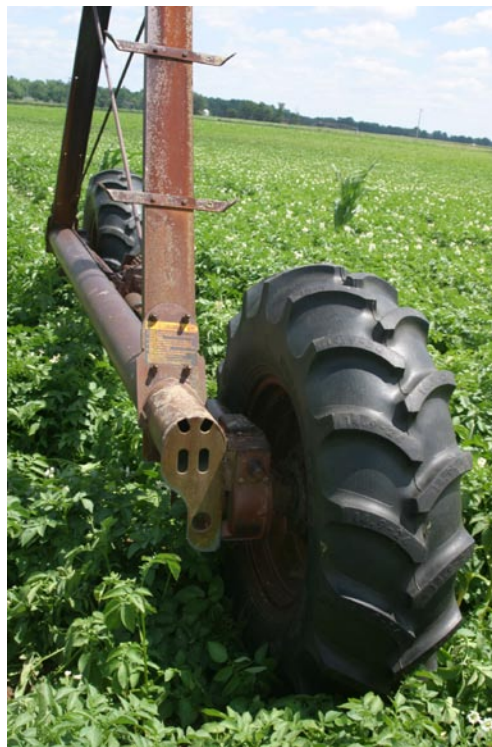
Figure 11. Close view of the base of the incident irrigation tower.
