MIFACE Investigation Report #10MI144

Subject: Hispanic Roofer Dies After Falling Through an Improperly Secured Roof Hatch Cover

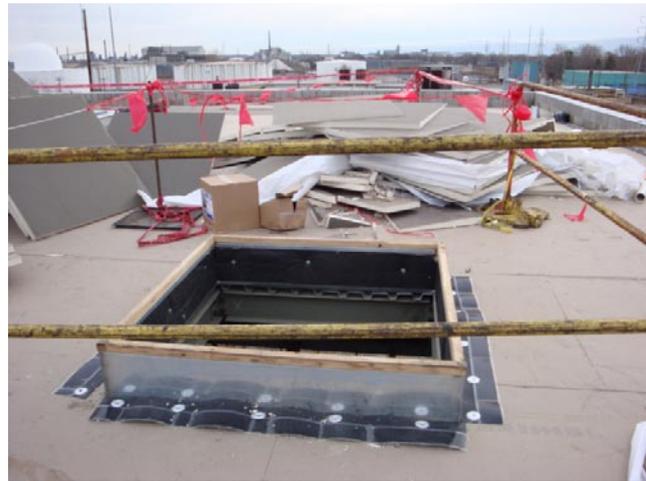
Figure 1. Roof hatch involved in incident. Note nearby pile of insulation sheets.

The incident occurred in the southeast corner of the roof. The roof cover involved in the incident was 22-gauge sheet metal, which was not secured. The sheet metal had the word HOLE written upon it in orange paint.

Located near the incident roof hatch was a pile of insulation sheets. At approximately 9:30 a.m., the decedent was assisting the foreman in moving the insulation sheets to the appropriate area of the roof for engineered roof drainage.

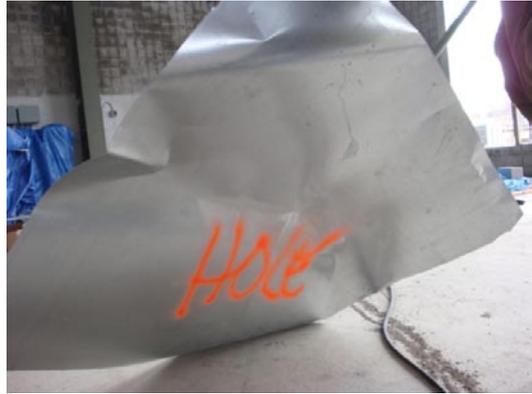
Figure 2. The word HOLE written in orange paint on top of the sheet metal cover involved in the incident.

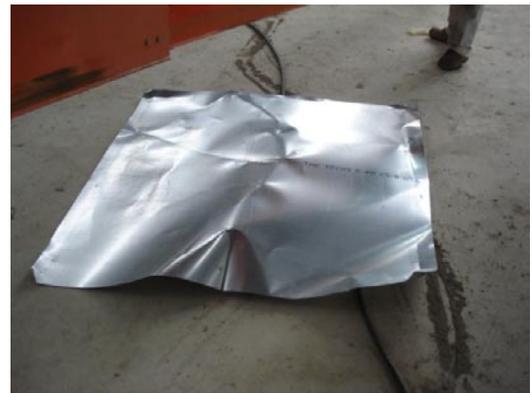
The foreman indicated that the decedent had lifted a sheet of insulation. The foreman heard a noise, turned around, and witnessed the decedent fall on the metal cover. The foreman attempted to grab the decedent without success. The cover gave way and both the cover and the decedent fell 48 feet to the concrete floor below.

Figure 3. Sheet metal cover after it fell 48 feet to the ground.
